## **Rail Delivery Group**

# **Guidance Note – Selection and Assurance of Fasteners for Legacy Fleets**

## **Synopsis**

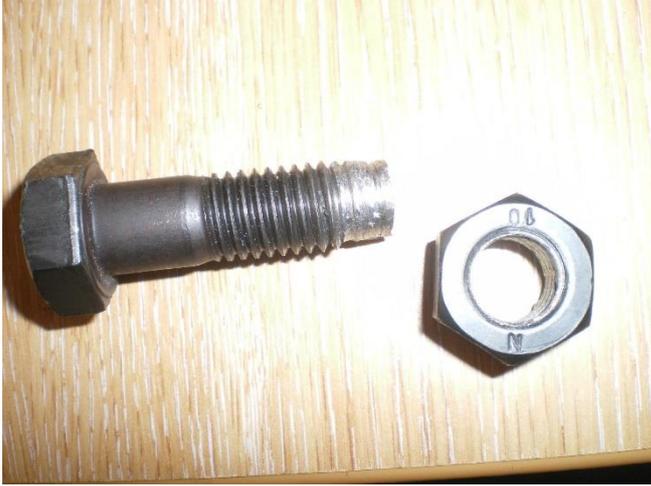
Summary	Investigation into defective bolts highlights the longevity of the supply chain and the benefits of adopting modern ISO standards with consolidation to one manufacturer.
Background	<p>Whilst undertaking a wheelset change on a Class 158, it was evident some of the M14 Cardan Shaft fasteners did not tighten correctly. Fitment of the nut proved inconsistent and removal of the fasteners proved difficult resulting in severe thread stripping.</p> <p>Initial findings identified the suspect bolts to have been marked 'BCSF'. Testing was undertaken on fasteners supplied by an alternative source giving satisfactory results, indicating the problem lied with 'BCSF' stamped bolts.</p> <p>Similar tests were carried out on the M16 fasteners with the same results observed.</p>

<p>Bolts also displayed variable locking properties. When testing a batch of fasteners, it was possible to run the locking nut significantly past the end of the bolt. This occurred on two bolts. The nut was then tried on other bolts and it displayed locking properties indicating that the issue was with the bolt formation.</p>

Scope	<p>All BCSF M14 and M16 bolts were quarantined to prevent further supply. An investigation was undertaken by Unipart Rail Ltd [URL], involving their supplier and independent industry experts.</p> <p>A sample of defective and compliant bolts were sent for thread forming and metallurgical investigation. Load testing was carried out on "re worked" &amp; rejected BCSF bolts after being torque tightened to the required limits. The effective joint interface clamping force was measured and compared with the OEM design authority tolerances for the cardan shaft joint integrity.</p>
Analysis & Findings	<p>Bolts with head stamping 'BCSF' were found to exhibit the thread stripping and nut removal concerns (other head markings were found not to be affected).</p> <p>The independent investigation identified that bolts stamped with 'BCSF' had a different thread form. On tightening, the inconsistent thread form of the 'BCSF' bolts meant they would not freely engage with the thread of the nuts and would</p>

<p>require a higher torque to tighten the nuts. When undoing a threaded nut on the affected bolt, the threads would fracture, seizing the nut to the bolt.</p> <p>Test conducted on M14 and M16 bench test pieces (torqued to 195Nm &amp; 290Nm respectively) and inspected with a feeler gauge revealed no gap between the two mating faces.</p> <p>The independent analysis indicated the thread form of the affected “BCSF” bolt did not meet the British Standard (BS3692). The limited sample size of bolts tested may not have been a true reflection of the overall quality of the batch delivered.</p> <p>The M14 &amp; M16 bolt supplier confirmed the bolts were to the specification, albeit towards the top end of the tolerance, within 0.04mm of top limit. This, allied to heat treatment and phosphate processing, can lead to thread roughness and bruising issues; however, this would not cause an interference fit on standard nuts. The parts were checked using a pitch micrometer and found to be within the specification for 6g bolt threads. The ring gauge was accepted but was tight where bruising was evident; no oversize conditions were found. When nuts were checked on alternative sourced bolts, no issues were identified therefore suggesting the root cause was identified as BCSF bolts.</p> <p>The bolt thread checking gauge used by BCSF was correctly calibrated and within date.</p> <p>Having checked a Depot Maintenance Manual for the “in service” cardan shaft examinations it indicates the torques checked are 20% below the initial torque loadings. However not all depot maintenance instructions call for this level of checking; some only require to be checked for looseness with a spanner.</p>

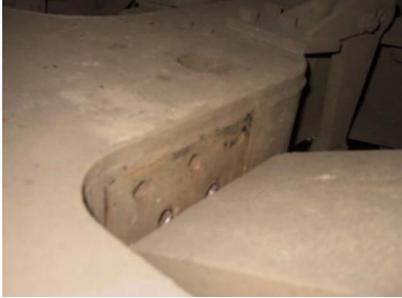
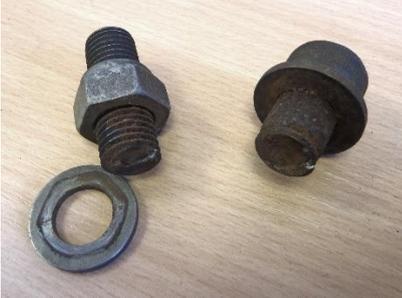
Summary	Review of history of the brake hanger fastener arrangement highlights a variety of design and maintenance issues affecting joint integrity
Background	<p>The BX1 and BT13 bogie type is fitted to a range of EMU fleets dating from the 1970s, including classes 313, 314, 315, 317, 318, 319, 320, 321, 322, 455, 507 and 508. The typical use of such units on frequent stop, inner-suburban services means that the joint is subject to significant cyclic loads due to the high number of braking applications. This has exposed a number of design weaknesses in the brake hanger bracket fastening arrangement, with a long history of failures including at least one mainline derailment recorded.</p> <p>The original tapping plate arrangement was augmented by the use of ‘Tappex’ inserts to counter the effects of wear. A through bolted arrangement is now the preferred solution and many bogies have been modified to this arrangement. Maintenance arrangements have been implemented over the years as a result of lessons learned.</p> <div style="display: flex; justify-content: space-around;">

Scope	A study of the content of previous NIRs raised to highlight the various issues that can affect the integrity of the joint.
Analysis & Findings	<p>The content of the following NIRs has been reviewed:</p> <ul style="list-style-type: none"> <li>• NIR1291 Brake Hanger Fixing Bolts (This relates to the derailment of 313106 at Willesden on 4<sup>th</sup> March 2002)</li> <li>• NIR1302 Brake Support Bracket Securing Bolts with Tappex Inserts (Class 318)</li> <li>• NIR1433 Class 314 Brake Support Bracket Failure (came adrift)</li> <li>• NIR1446 Brake Support Hanger Bracket (Class 313)</li> <li>• NIR2008 BX1 Brake Hanger Bracket Repair Process (Class 507/8)</li> <li>• NIR2317 BT13 and BX1 brake hanger bracket cracks (Class 455)</li> <li>• NIR2430 Class 318 Brake Hanger Bracket Bolt missing</li> <li>• NIR2715 Class 507 Brake Hanger Bracket Bolt Broke</li> <li>• NIR2893 Class 313 Brake Hanger Bracket Bolt Failure</li> <li>• NIR2916 Failure of bolt on Through-bolted Brake Hanger Bracket (Class 313)</li> </ul> <p>The following issues are highlighted in the above NIRs:</p> <ul style="list-style-type: none"> <li>• A lack of surface flatness between the mounting face of the bracket and the bogie transom mating area can be a cause of failure. Specification CR/TP1118 incorporates a combined surface flatness tolerance of 0.25mm. Surface flatness can be affected by corrosion in this area.</li> <li>• Poor alignment between the bogie transom and the brake hanger.</li> <li>• The tapping plate arrangement proved to be a less robust method of assembly than a through-bolted joint. The adoption of Tappex inserts,</li> </ul>

<p>originally believed to be a solution to the hanger, did not prove effective and failures occurred to bogies which had been so modified.</p> <ul style="list-style-type: none"> <li>• The through-bolted modification to specification CR/TP1146 has generally been adopted.</li> <li>• The use of the correct bolts of sufficient length is a critical issue. Fasteners with a very short (5mm) shank length have been used previously. The standard for an M16 x 65 bolt allowed a shank length of 21mm. The stress concentrations in a bolt are under the head, at the transition from the shank to the first full thread and at the first thread under the nut. Design practice is to keep these three stress concentrations at least two thread pitches apart.</li> <li>• More recent failures (since the through bolt modification) have highlighted corrosion being the cause of premature bolt failures.</li> </ul>
<p>Deliverable(s) or lessons learnt</p>	<p>The following practices, which are a combination of running maintenance and classified repair (overhaul), have been adopted over the years.</p> <ul style="list-style-type: none"> <li>• A VMI ‘Crow bar test’ to check for movement in the joint</li> <li>• Inspection holes to facilitate ultrasonic testing of bolts.</li> <li>• Torque testing of bolts during overhaul (where the bracket is not otherwise being removed) to check for any cracked or weakened bolts. A torque figure of 25Nm has typically been recommended.</li> <li>• Where the bracket has been refitted, a yellow paint indication to verify that the specified torque tightening sequence has been applied to each fastening.</li> <li>• Correct bolt configuration (i.e. whether they should be inserted from the inside or outside). Where a Durlok nut is used, the bolt should be passed through from the outside with the Durlok nut to be fitted on the inside. This is because the Durlok nut has a serrated face to assist in locking, so when the joint is tightened the torque <b>MUST</b> be applied to the bolt, hence the bolt head has to be on the outside. The washer goes between the bolt head and the bracket. Where a Nyloc nut is used, the bolt can be fitted in either direction.</li> </ul>

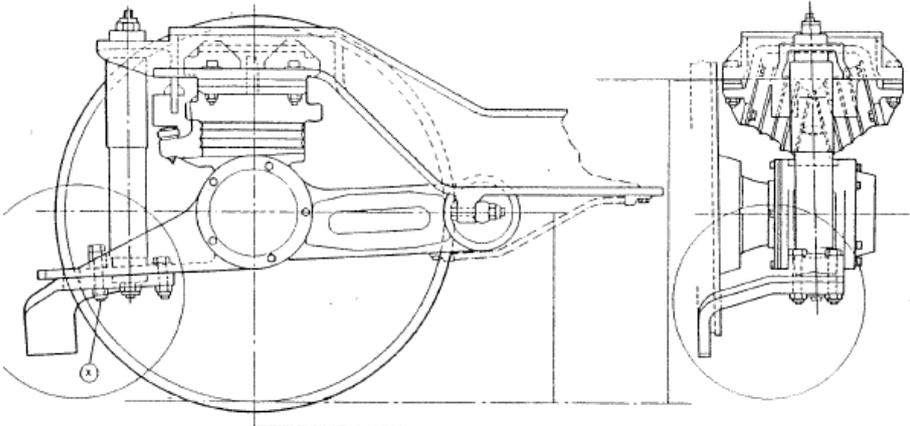
Scope	The accident was investigated and reported in a HSE railway accident report, in relation to the inquest into the death of the driver which resumed on 21 <sup>st</sup> Nov 1989. This sought to establish the root cause of the accident.
Analysis & Findings	<p>Traditional designs of the lifeguard fixings had been by bolts fitted with castle nuts locked in place by split pins through holes in the bolts. The drawback to this arrangement was that the holes and castellations must be in line and, therefore, the nuts may not be tightened fully, reducing somewhat the strength and hence the effectiveness of the lifeguard.</p>

<p>To meet the lifeguard impact load specification for the Class 150 type, a newer type of fixing, comprising four 20 mm diameter bolts secured by 'bent beam', Philidas nuts, was adopted. Although a 'bent beam' nut requires additional torque to move on the thread, the important factor is the design pre-load. The design drawing for the Class 150 bogies specified 476 Nm, for which a 3 ft (1m) torque wrench would be required, equipment that was, at the time, not normally carried by artisan staff but available for use at main depots.</p> <p>If the nuts are disturbed for any reason and not subsequently re-torqued to the correct figure, Philidas nuts may become loose through vibration in service. Continuous re-checking of the torque can lead to a loss of effectiveness of the self-locking feature; Philidas Ltd advised the HSE inspector that they could be used up to ten times and tightened to the prescribed torque and still behave satisfactorily.</p> <p>On 8 September 1988, following a defect report in traffic, the leading left-hand lifeguard on car No 52209 was found to be slightly loose, all bolts being present but slightly loose. The nuts were tightened using a ring spanner and a</p>

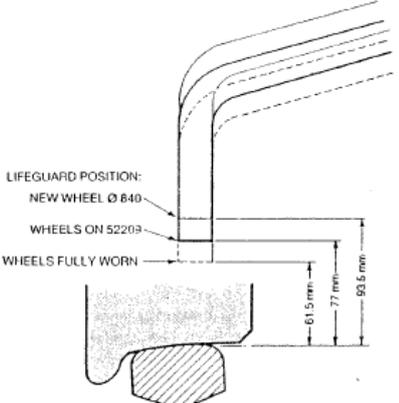
<p>short ratchet tool by an outstation maintenance supervisor, who was otherwise unaware of the considerable torque required to secure the newer type of nut. BR's own investigation led to the following conclusions as to the sequence of events leading to the derailment:</p> <p>a) The two inner bolts of the left-hand leading lifeguard on vehicle No 52209 were missing and had probably been missing for several hundred miles before the derailment occurred.</p> <p>b) The outer two bolts on the lifeguard were in position but were loose at the time of the derailment. Both of these bolts had probably been loose for several hundred miles before the derailment.</p> <p>c) The lifeguard was loose enough to be hanging down towards the rail, at an angle of about 8'.</p> <p>d)The amount by which the lifeguard was loose was possibly enough to reduce the nominal clearance to rail track from 77 mm to 27 mm.</p> <p>e) The loosely hanging lifeguard on vehicle No. 52209 struck a substantial concrete block (and possibly other pieces of concrete) at a speed of about 45 mph some one and a half miles before St Helens Central Station on the evening of 11 November 1988.</p> <p>f) The impact of the lifeguard on the block would have been sufficient to bend the bolts, elongate the holes in the lifeguard, further reducing the clearance to the rail head.</p>

<p>Immediately following the incident, a fleet check was undertaken of the lifeguard bolts of Class 150s, revealing:</p> <ul style="list-style-type: none"> <li>• 1 lifeguard missing</li> <li>• 1 lifeguard bent and subsequently changed</li> <li>• 2 bolts missing (on separate units)</li> <li>• 14 bolts on various units required tightening to the prescribed torque</li> </ul>

<p>Deliverable(s) or lessons learnt</p>	<p>The report made recommendations of relevance to fasteners as follows:</p> <p>Self-locking nut and bolt assemblies (as an example of components that are the subject of special instructions) should be identified by sealing or comparable means so that people who do not have access to information readily are aware that special instructions exist and can take appropriate action.</p> <p>All rolling stock fitted with lifeguards secured by self-locking nuts shall be subject to a common practice of replacement of both nuts and bolts on detection of looseness. (BR had already committed to this practice on account of its own investigations in the aftermath of the accident).</p> <p>The accident graphically highlighted that more modern types of fasteners are not fool proof and require specific maintenance arrangements and instructions accordingly.</p>
<p>Impact and / or feedback</p>	<p>The accident happened at a time when the wider adoption of quality / safety management systems was just starting to be implemented by British Rail. The outcome of the investigation and the corresponding recommendations may therefore seem rather basic, almost naïve by current standards; however, the accident serves as a continual reminder of the rationale behind modern day maintenance practices.</p>

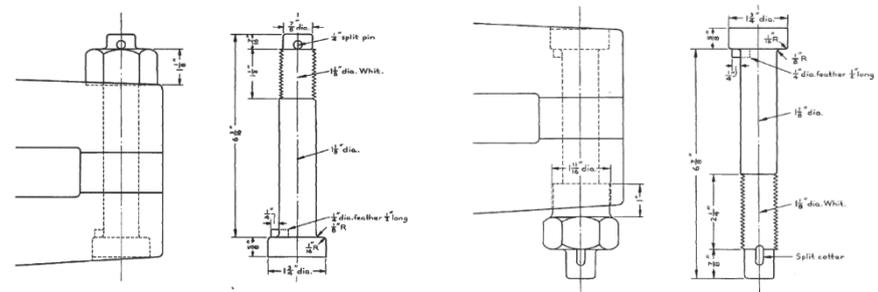
<p>Scope</p>	<p>The accident was investigated and reported in a Ministry of Transport railway accident report, dated 19<sup>th</sup> April 1960. This sought to establish the root cause of the accident.</p>
<p>Analysis &amp; Findings</p>	<p>The accident report records that an extensive search of the line took place and many of the missing components were found at various places along the route, the first some 33 miles from the scene of the eventual accident.</p> <p>The driver had reported a noticeable ‘knocking’ from the motion earlier in the journey and had stopped at Garsdale station to examine the locomotive but was unable to find anything untoward (the report acknowledges the extreme weather conditions on a dark, January night).</p> <p>The bolts had been reported as loose (and tightened up) at nine separate inspections in between its last overhaul and the day of the accident.</p> <p>The investigation into the accident identified that the design of the front fixings of the slide bars made it difficult to tighten the nuts at the top of the bolt assembly, including the insertion of the split pin, due to the presence of the adjacent steam chest cover.</p> <div data-bbox="730 1485 1390 1933" data-label="Image"> </div> <p style="text-align: center; font-size: small;">Photograph 3. Front end of slide bar assembly before modification</p>

<p>Deliverable(s)</p>	<p>A relatively simple redesign (which was actually in hand at the time of the accident) reversed the position of the nut and bolt arrangement, and replaced the split pin with a cotter, as illustrated by the following drawings:</p>
